RE: Applications for Amendment to Memorandum of Understanding (MOU)
(1) Waiver of Fish Passage at Upper Pony Creek Dam (UPCD); and
(2) Waiver of Fish Passage at Lower Pony Creek (LPCD)

Executive Summary	Section One
Fish Passage Waiver Application, Lower Pony Creek Dam	Section Two
Request for Amendment of MOU for Fish Passage, Upper Pony Creek Dam	Section Three
Proposed Mitigation at Matson Creek, 30% Design	Section Four
Baseline Conditions at Pony and Matson Creeks, AHI Surveys	Section Five
Letter of Support, The Wetland Conservancy	Appendix
Letter Authorizing Construction of Lower Pony Creek Dam, Governor Atiyeh	Appendix

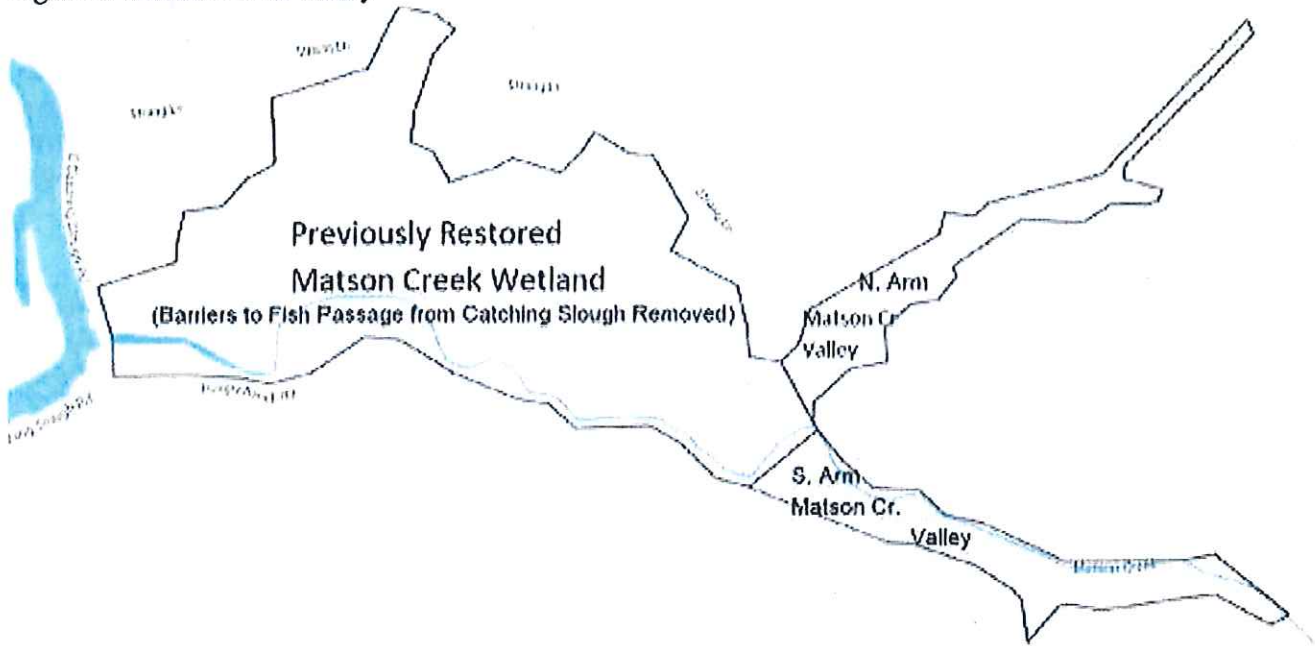
Figure 3: Matson Creek Valley

6. STREAM DESCRIPTION
 The mitigation site is located in the Catching Slough Sub-Basin, approximately 7 miles south east of the AO. (Figure 3) The Catching Slough Sub-Basin is a stream and slough system that was historically “sinuous and marshy and provided highly productive rearing areas for juvenile salmon including coho.” (CWA, 2009) The North Fork Matson Creek runs through open pasture lands amidst a wide, active floodplain and adjacent to forest uplands. The North Fork has been channelized and moved to the south side of the valley which has created conditions for pasture grass versus wet meadow species. Riparian vegetation includes either salmon berry and alders or sedges, perennial grasses and ferns depending on the reach.

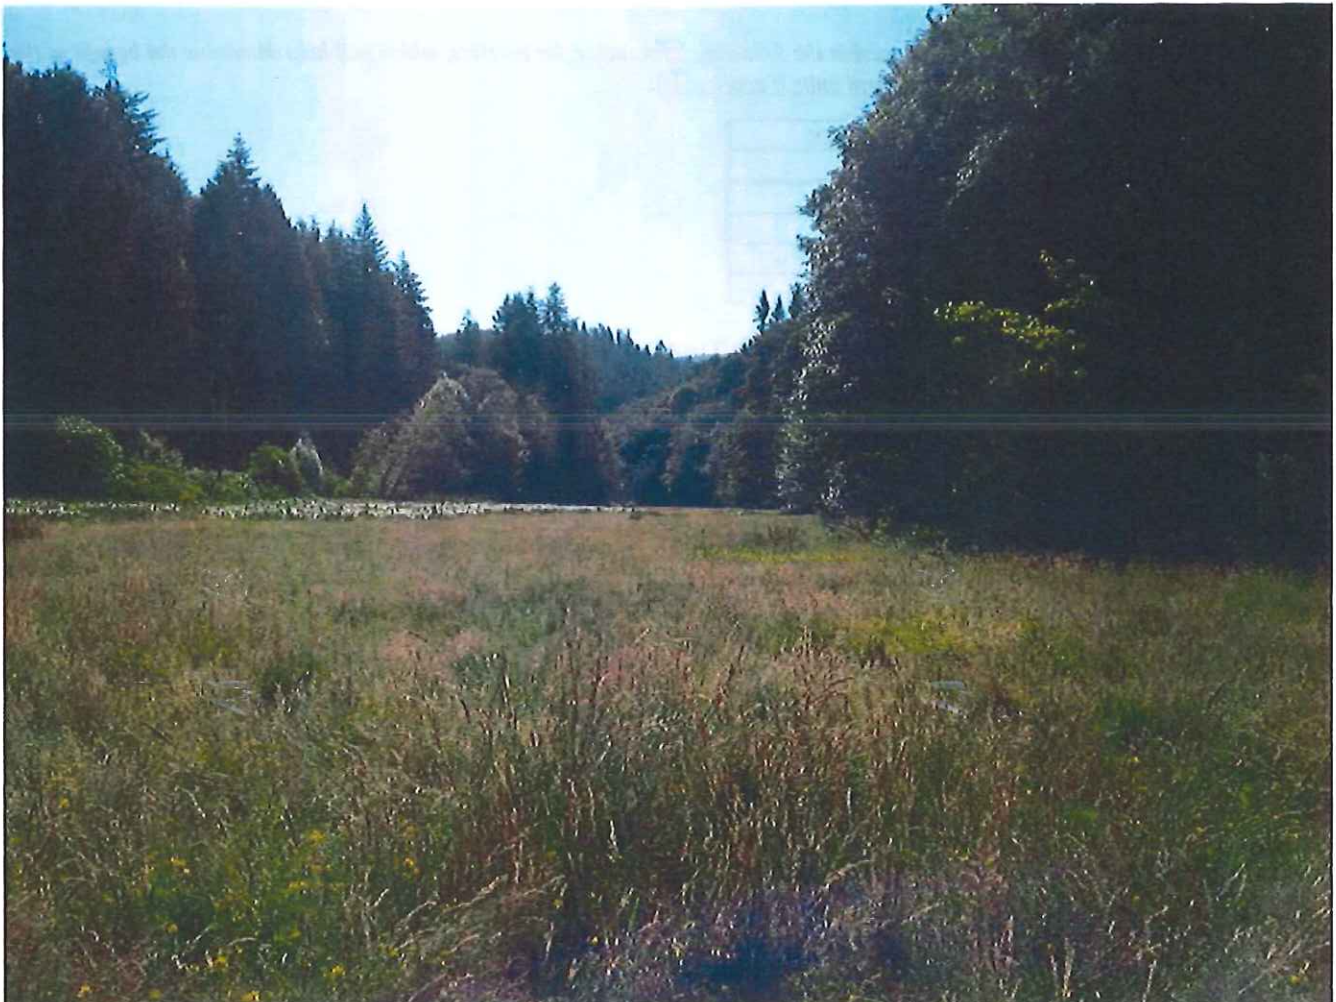
Photo 4: Looking NE up the North Arm Matson Valley

The proposed mitigation site for waiver of fish passage at LPCD would occur on Matson Tributary #1, located in the North Fork Matson Creek valley which encompasses approximately 9 acres of wetland and pasture. (Figure 4, Photo 4) The wetland area can be found near the confluence of the North and South Forks of Matson Creek. Vegetation here consists of obligate wetland species including cattail, slough sedge, small-fruited bulrush, and burreed. The upper valley consists of the typical agriculturally modified riparian area. The North Fork has been channelized and moved to the south side of the valley which has created conditions for pasture grass versus wet meadow species. Vegetation on the valley side of the riparian buffer has been cleared while vegetation on the upland side of the creek consists of red alder, salmonberry, red elderberry, big leaf maple, Sitka spruce, and myrtlewood. The forested northern edge of the valley consists of mixed conifers species (Douglas fir, Sitka spruce, Western red cedar, Western hemlock) interspersed with myrtlewood, big leaf maple, and madrone. The main threats to native plants in this valley are from encroaching blackberry and competition with the established prairie grass. Fortunately, reed canary grass, a highly invasive grass, is found in limited quantities in this valley. Active establishment of native riparian and wetland vegetation is necessary for the development of a diverse plant community to outcompete invasive species. (CWA, 2014)

Winter habitat remains the most limiting habitat type in the Catching Slough sub-basin. Winter coho habitat is most commonly characterized by pools that provide refuge from high winter flows - especially secondary, off-channel and beaver pools. The proposed length of North Arm Matson Creek runs through open pasture lands amidst a wide, active floodplain and adjacent to forest uplands. Limiting factors for coho were identified by CWA in their 2009 assessment of the sub-basin as shade deficits, lack of large woody debris, undesirable pool depth and frequency. The publication further states that; “These unconstrained single channels would have the potential to improve coho rearing habitat if allowed to meander across the relatively wide valley floors and improving channel-floodplain connectivity.” (CWA, 2009)

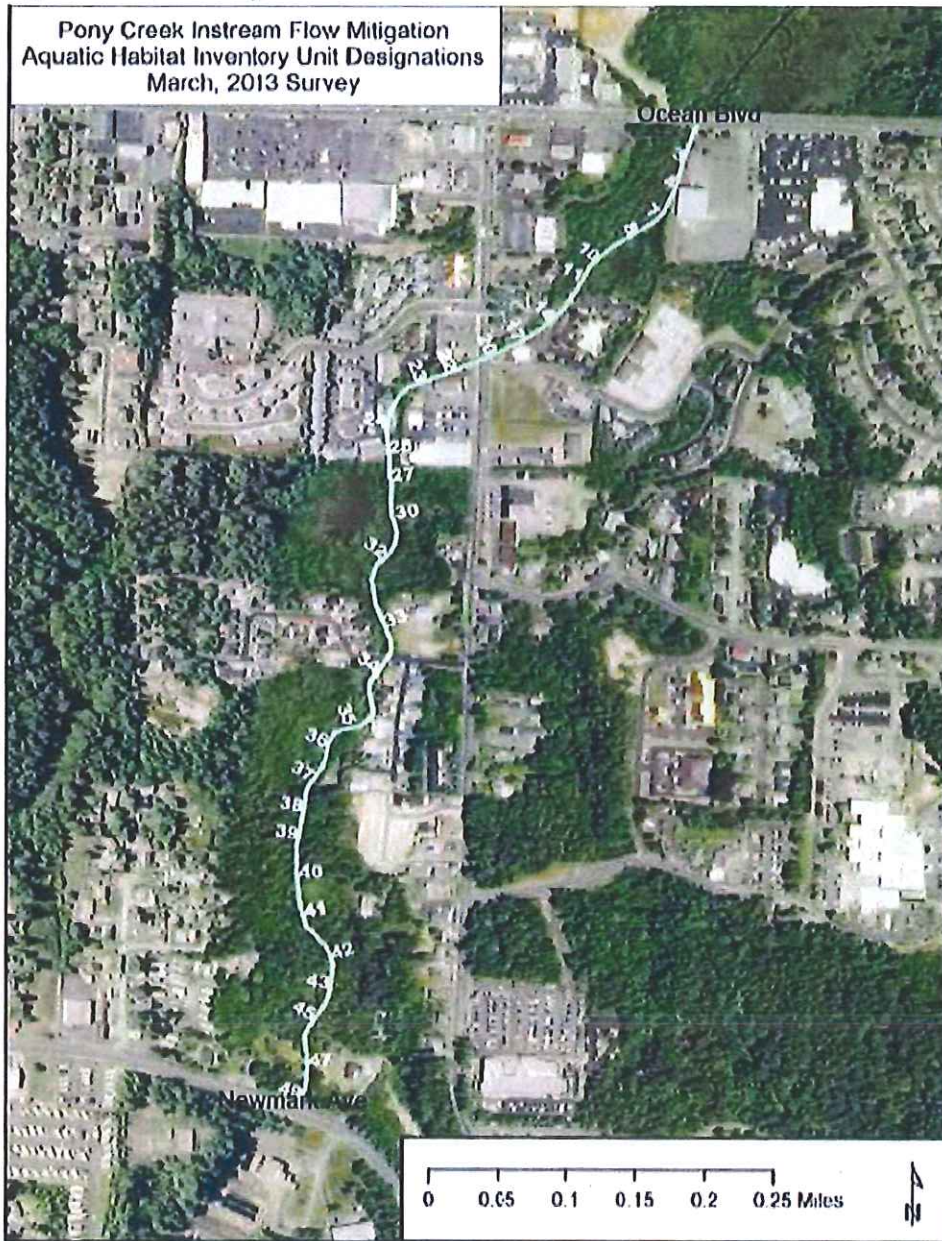
Figure 2: Lower Pony Creek

The reach of lower Pony Creek affected by this proposal extends from LPCD to Newmark Avenue and is approximately 0.7 miles (3,696 ft.) long. Below Newmark Avenue, the basin is tidally influenced with occasional tidal/storm surge events extending above Newmark. The reach runs through a combination of residential and urban/commercial landscapes with significant development of buildings and impermeable surfaces built to the stream's edge in many areas (Photos 1-2, Figure 2).

The existence of the dams upstream precludes the recruitment of gravel to lower Pony Creek. An assessment and action plan for the lower Pony Creek watershed identified the geology of this basin as primarily sandy loams and clay formed by sedimentary marine terraces (LPCWC, 2001). The assessment also identified summer water temperatures “stressful” to fish and aquatic life. The Aquatic Inventory Survey (ODFW 2000) identified areas of “orange slime”, “oil in the water, and “petrol odors”, likely associated with residential and commercial development, and collection/transport from impermeable surfaces such as roads, parking lots, and building roofs.” (ODFW, 2011)

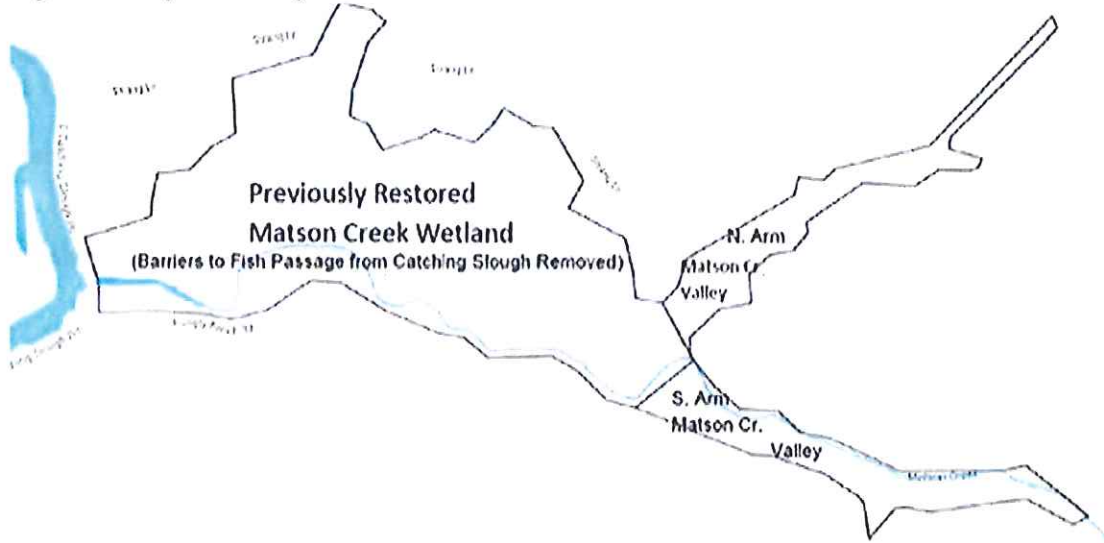
Figure 3: Proposed Mitigation Location

The proposed mitigation site resides within the Matson Creek valley and is contiguous to Mainstem Matson Creek to which full natural tidal hydrology was restored by the Water Board pursuant of wetland mitigation credits. A simultaneous application for Waiver of Fish Passage at LPCD has been submitted for department review proposing a complimentary mitigation of the North Fork Matson Creek (Figure 3).

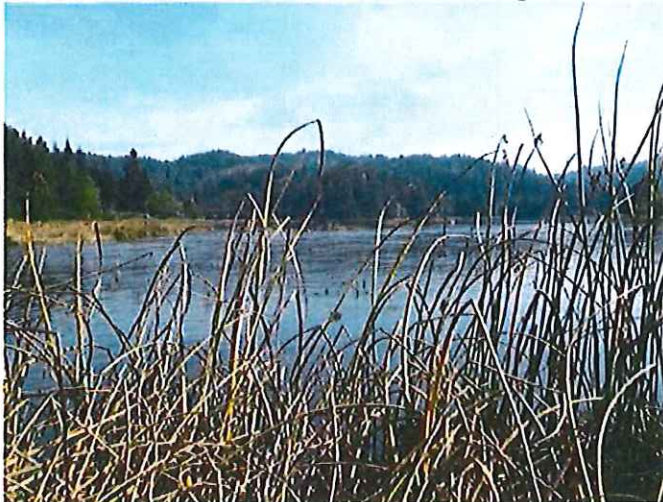
Photo 3: Matson Creek Wetland Restoration, looking East from Catching Slough

PLEASE PROVIDE ADDITIONAL DETAILS REGARDING THE INFORMATION PROVIDED IN THE SUMMARY TABLE (such as species listed under the state or federal ESA and descriptions of the stream channel and riparian habitat): The proposed Matson Creek mitigation actions would take place in the Catching Slough sub-basin in which Coho, chinook and winter steelhead have been documented in addition to Chum salmon and Sea-run Cutthroat. Coho and Steelhead have each been observed in Matson Creek. "Anadromous fish are distributed widely throughout the sub-basin due to the highly complex, low-gradient stream systems." A wide variety of amphibian and non-salmonid fish species are also observed in the Catching Slough subbasin. These species include, but are not limited to Cottids, Brook Lamprey, Pacific Lamprey, Stickleback, Pacific giant salamander, Dunn's salamander, roughskin newt, tailed frogs, red-legged frog, Pacific treefrog, and foothill yellow-legged frog. There are over 58.64 kilometers of summer and winter rearing habitat throughout the sub-basin, with almost 29 kilometers of that area used for spawning during the winter months in mainstem reaches and adjacent tributaries. Fish use of the named tributaries end at high gradient segments where both boulders and or bedrock are present. (CWA, 2009)

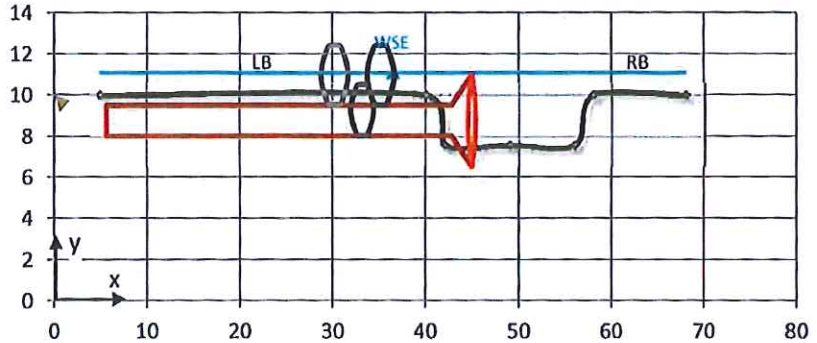
Proposed Cross-Section and Structure Geometry (Looking D/S)

Wood Species	Rootwad	L_T (ft)	D_{TS} (ft)	L_{RW} (ft)	D_{RW} (ft)	γ_{Td} (lb/ft ³)	γ_{Tgr} (lb/ft ³)
Douglas-fir, Coast	Yes	40.0	1.50	2.25	4.50	33.5	38.0

Structure Geometry	θ (deg)	β (deg)	Define Fixed Point	x_T (ft)	y_T (ft)	$y_{T,min}$ (ft)	$y_{T,max}$ (ft)	A_{TP} (ft ²)
		80.0	0.0	Rootwad: Crown	45.00	11.00	6.50	11.00
